"The Difference is Experience"

Exterior

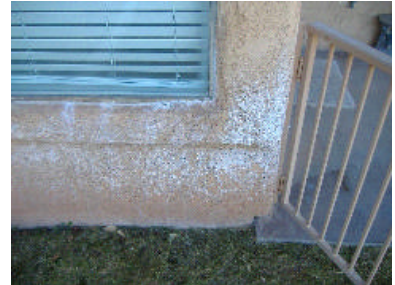
1.) Cracks noted are typical, 2.) Irrigation water has damaged and/or stained siding. Sprinklers should be relocated/redirected to prevent further damage.
