A/C -Air Conditioning System:

AIR CONDITIONER

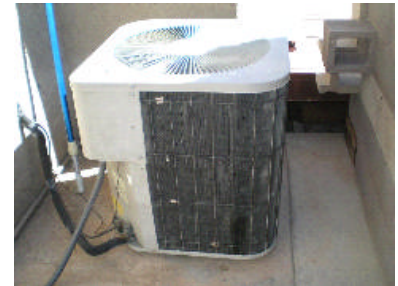
System Type Split System, Compressor Location, North side, Evaporator is located at the furnace.

Est. Age of Compressor in Years: Over 20 Years.

Air Conditioner Make: Goodman.

SAT	FAIR	POOR	N/A	N/I
Condensate Discharge:	p
Normal Controls:	p
Air Temp Drop:	14-16 degrees F. Considered acceptable.				
System Condition:	..	p

1.) Filter problems: Filter is soiled and should be changed. This can lead to poor performance and failure of the system. 2.) Age Factor: This air conditioner or

major components are beyond the expected useful life. Newer units are considerably more energy efficient. Consider replacement costs versus the costs of energy and ongoing repair costs of this older unit. 2.) Repair work performed includes a new fan motor.

Thermostat is a mechanical and/or non-programmable model. Consider replacement with a digital programmable thermostat for potential cost savings.

Although this system is working reasonably well today, homeowner should be prepared for replacement in the not too distant future.
